Orphans of the Storm

The Preservation of Architectural Plasters in Earthen Ruins

Frank G. Matero
Angelyn Bass

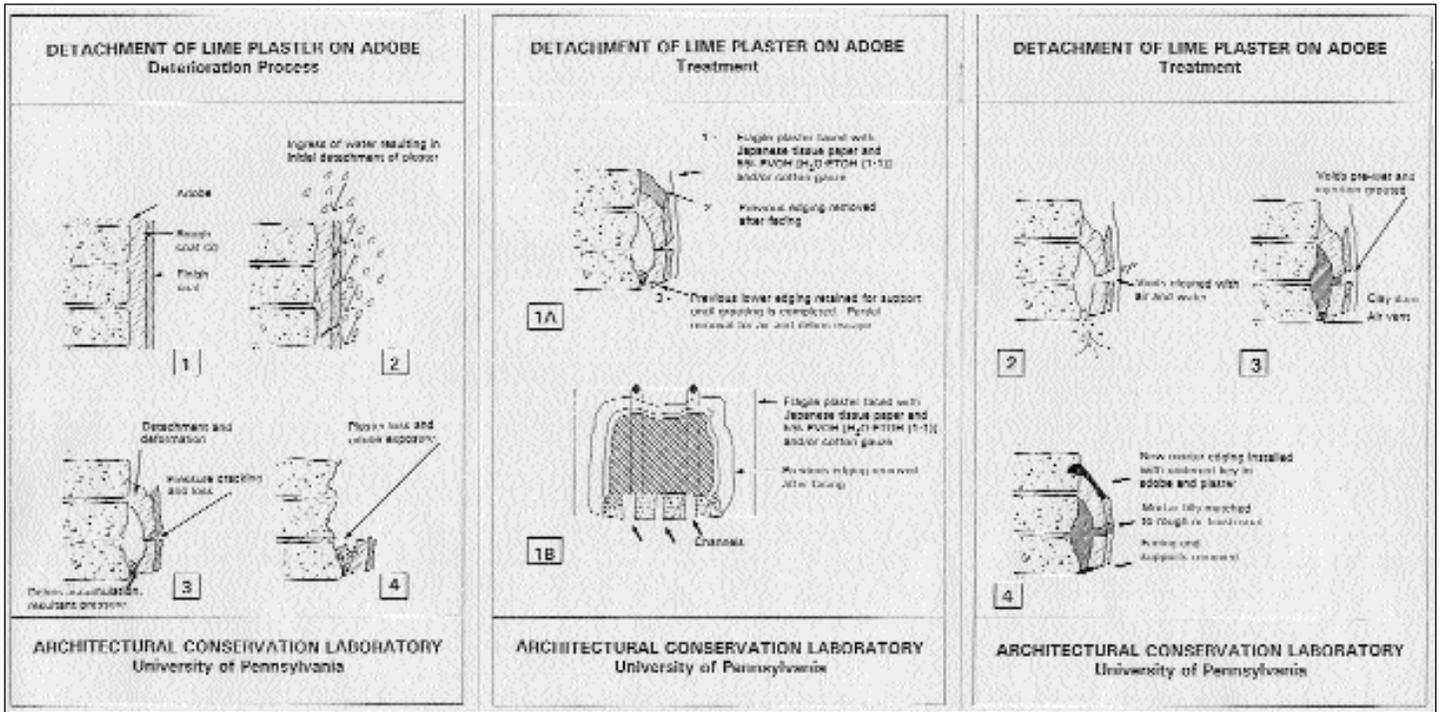
Fig.6. Detachment of lime plaster on adobe: deterioration process and treatment employed at Fort Union and Fort Davis during NPS study.

Grouting: Grouting is the injection of fluid mortars or adhesives to fill unwanted voids and readhere detached materials. Since grouting methods allow relatively deep penetration of the grout into inaccessible discontinuous areas, grouting is recommended to reestablish structural adhesion between plaster layers and/or their substrate, or to restore exfoliating masonry. Grouting mortars should be mechanically and chemically compatible with the plaster and masonry support material, reestablish structural adhesion between the plaster layers and substrate, and allow the passage of water vapor.

Compensation (edging and filling): (figures 6-4, 7 & 8) Abrupt edges at delamination points, surface holes, and cracks are all invitations for water penetration and its consequential array of conservation problems. While reconstruction of missing plaster was not the primary goal, completing deteriorated, or lost architectural details such as drip edges and contiguous surfaces essential to the proper shedding of water and structural infill in fragile isolated areas was considered necessary for the long-term durability of the plaster fragments.

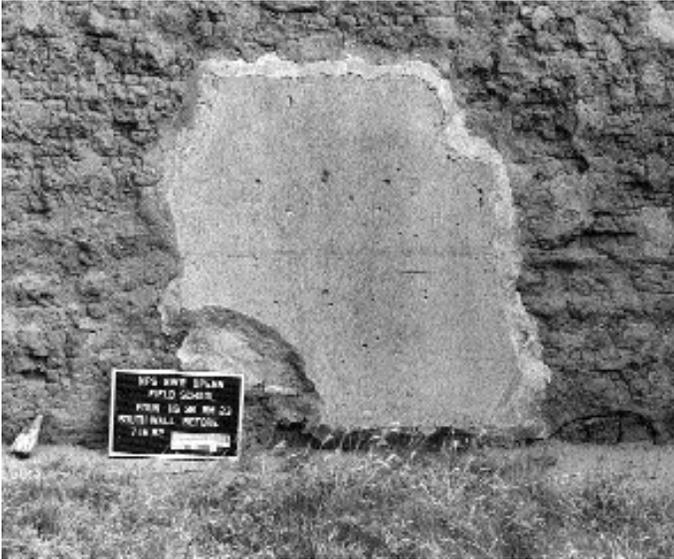
At Fort Union and Fort Davis many of the plasters had been previously edged with a lime-sand or cement mortar, all keyed with iron nails (figure 7). These edgings were cracked and unsightly due to their wide and irregular installation and were removed by hand with small chisels and mallets. This allowed access to the voids between the plaster and the adobe substrate for grouting. Debris, loose adobe and organic matter were removed from the open and blind voids with compressed air, brushes, and small tools.

Fig. 7. Mechanics Corral (HS 36), Room 23, Fort Union. Plaster fragment before recent conservation. Note unsightly and failed previous edging.

At Fort Union and Fort Davis edging of the plasters and filling of the cracks and holes were undertaken after the initial set of the grout, approximately 48 hours. All edgings were composed of lime putty or hydraulic lime and local aggregates selected for color and texture matching. In all cases the dry components were well mixed and the water stirred in until the mix was well blended. After the edging and fills were allowed sufficient time for an initial set, approximately 24 hours, the repairs were shaved down to the desired depth and texture and the surfaces were brush-stippled with 10% acetic acid to dissolve lime laitence and reveal the aggregate. Exterior edgings at Fort Union were partially capped with mud to protect the adobe wall-edging junction.

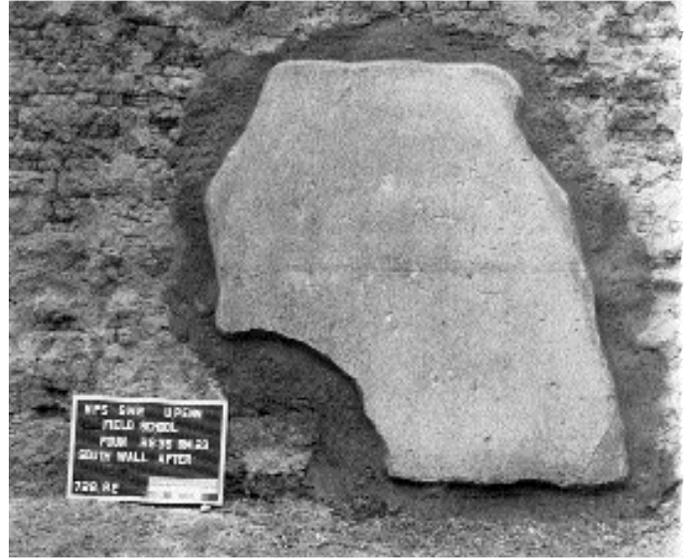
Fig. 8. Mechanics Corral (HS 36), Room 23, Fort Union. Plaster fragment after recent conservation. Note new edging flashed into adobe wall.
